Inspection Report

Property Address:
702 ROOSEVELT STREET
NAVASOTA TX 77868

PROPERTY INSPECTION REPORT FORM

SARA HUGHES	3/12/2025
<i>Name of Client</i>	<i>Date of Inspection</i>
702 ROOSEVELT STREET, NAVASOTA, TX 77868	
<i>Address of Inspected Property</i>	
Tom Rike	TREC 20478
<i>Name of Inspector</i>	<i>TREC License #</i>
<i>Name of Sponsor (if applicable)</i>	<i>TREC License #</i>

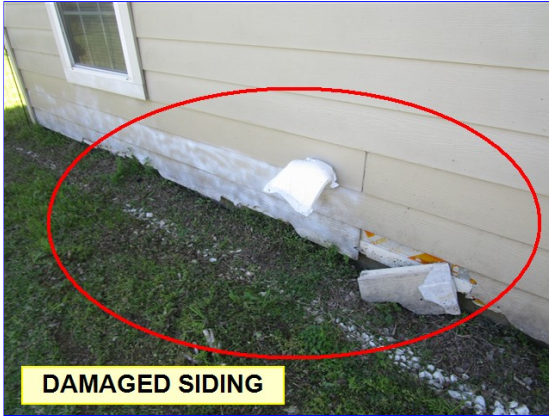
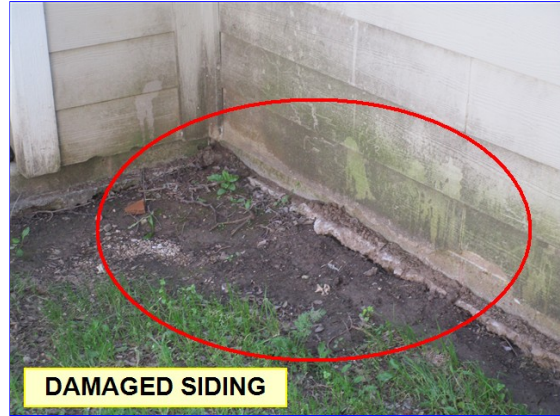
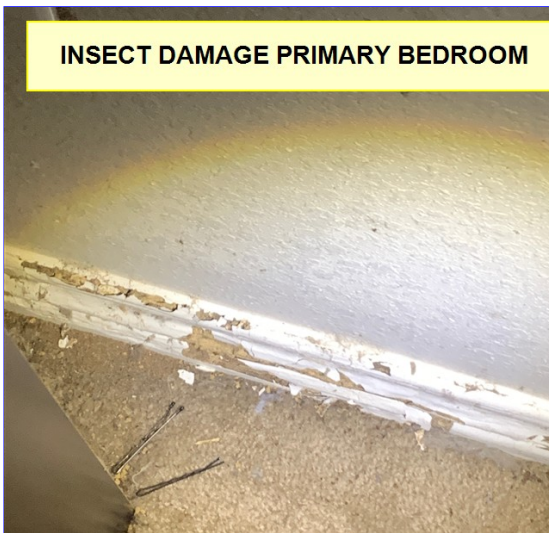
There was damage siding around the base of the unit.

There was insect damage along the base of the primary bedroom wall.

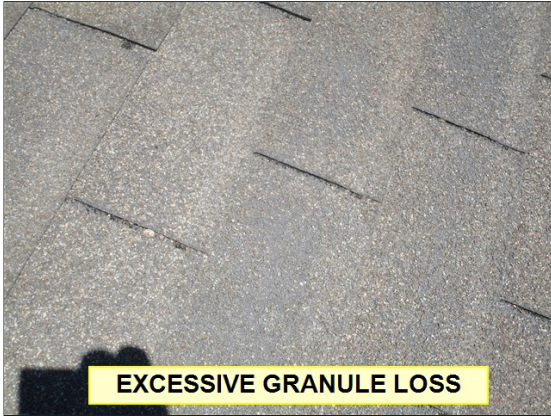
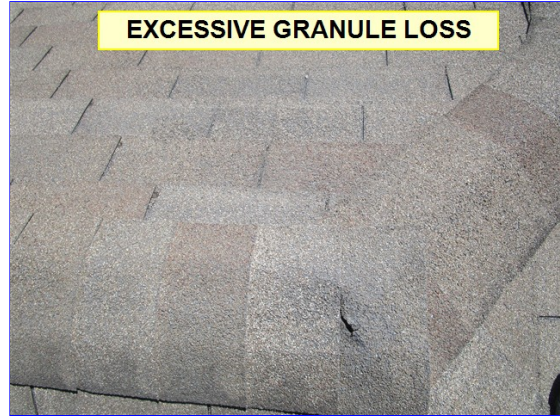
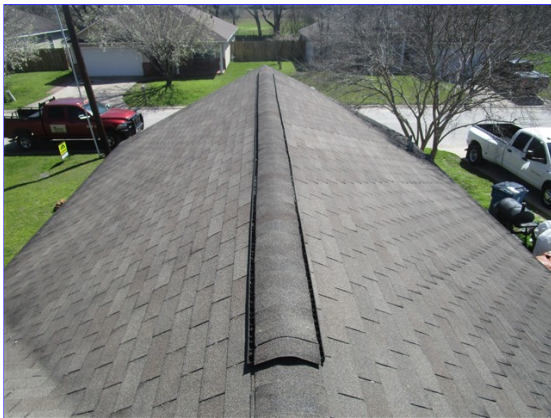
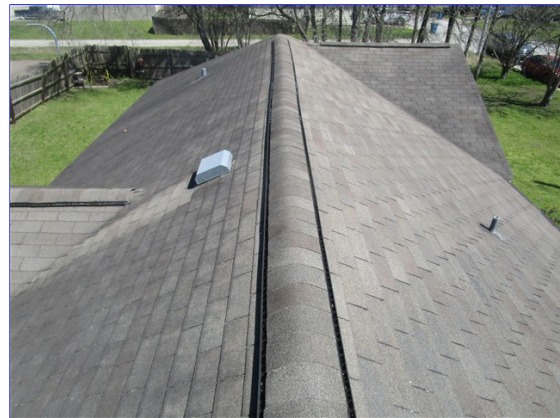
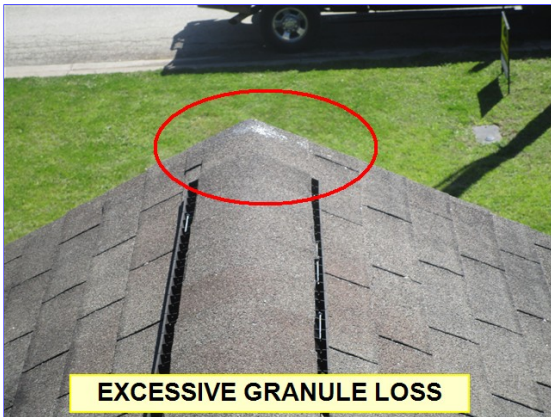
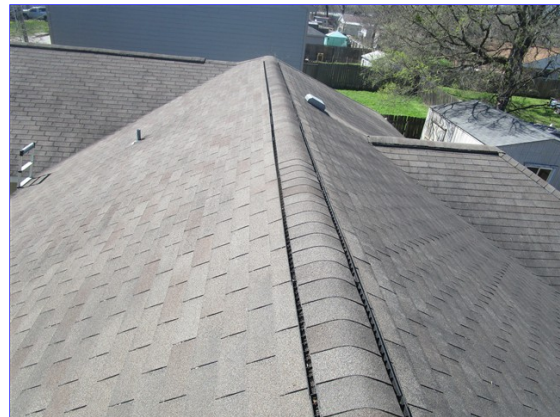
The roof has reached the end of its serviceable life. **Recommend replacement.**

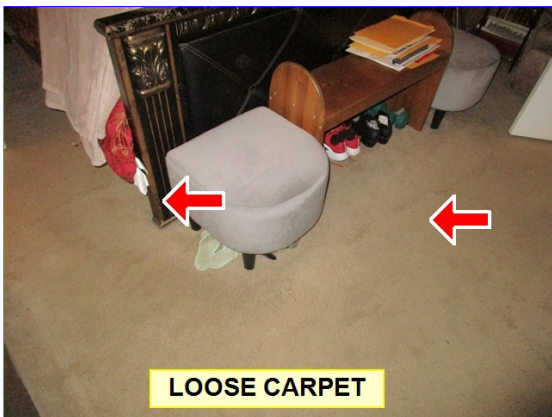
F. Item 1(Picture)

There was loose carpet throughout the unit.

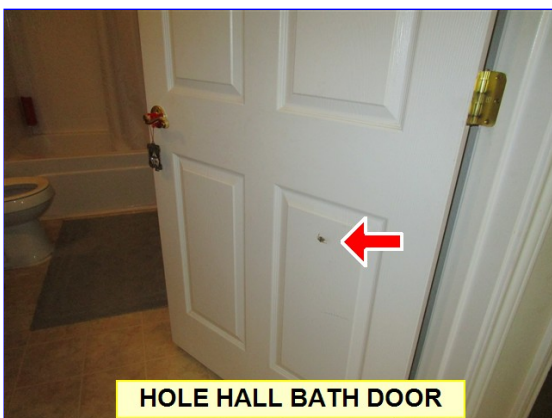
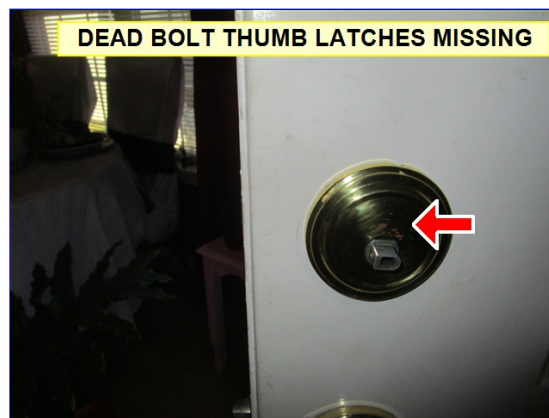
The garage occupant door dead bolt thumb latch was missing.

The rear exterior door dead bolt thumb latch was missing.

There was a hole in the hall bathroom door.

There was a dent in the overhead garage door.

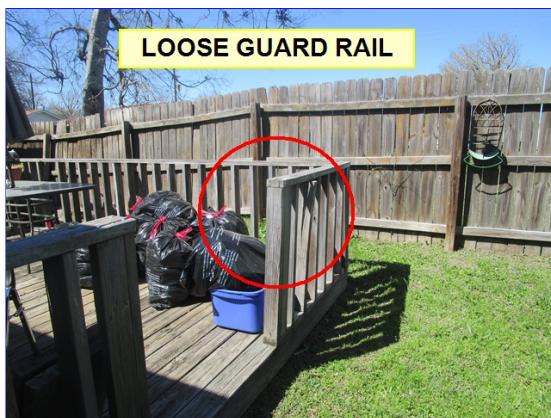
K. Item 1(Picture)

The rear deck was overall in average condition. There was loose guard rail. There was no visibility below the deck.

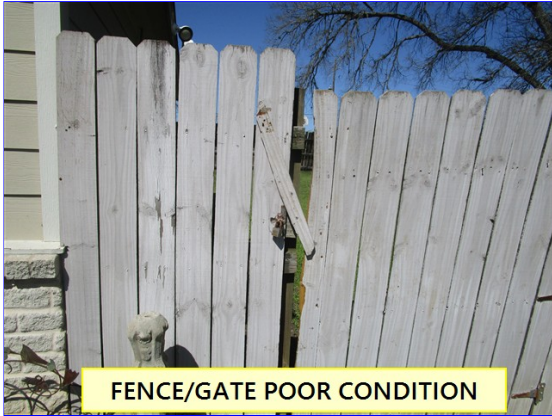
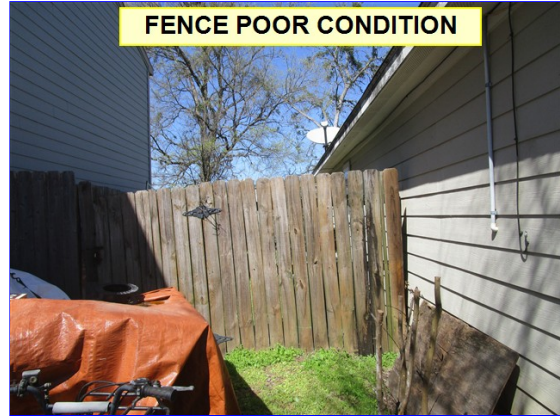
The fence and gates were in poor condition. Repair will be necessary in the future.

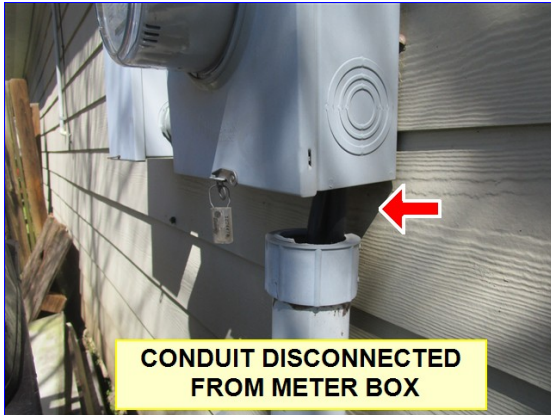
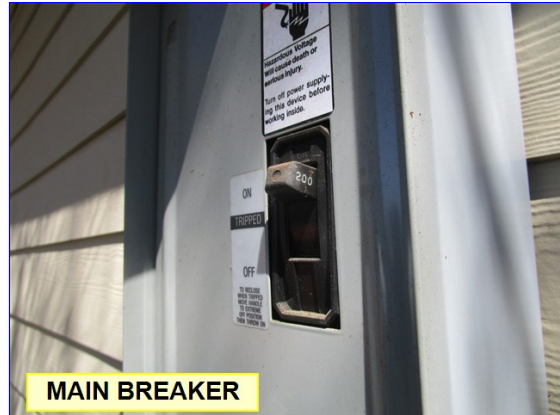
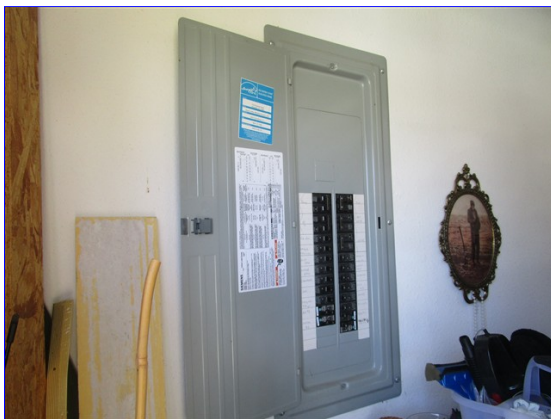
The conduit, for the main wire feed, was disconnected from the meter box. **Recommend repair for safety.**

There was not a surge protector present in the electrical panel. *This would not meet current building standards.*

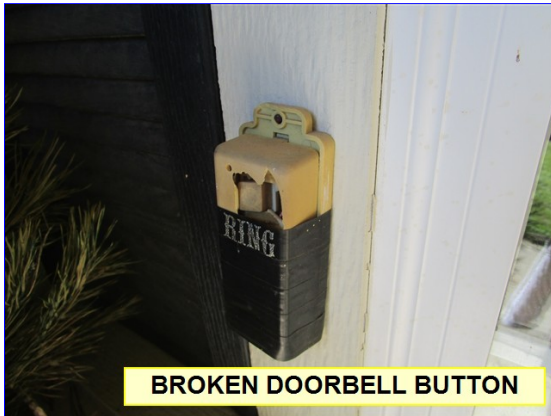
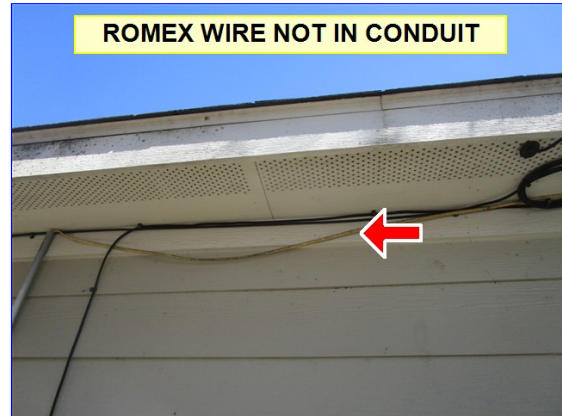
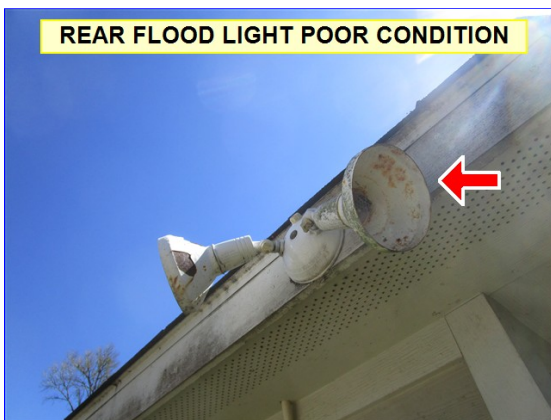
The smoke detectors inside the bedrooms were expired and need to be replaced.

The smoke detectors outside the bedrooms were expired and need to be replaced. Recommend installing smoke/carbon monoxide detector combo units outside the bedroom sleeping areas.

The rear porch light cover was missing.

The rear left flood light was in poor condition.

The kitchen fluorescent light was not operating and the cover was missing.

The primary bedroom closet light cover was missing.

The doorbell button was broken .

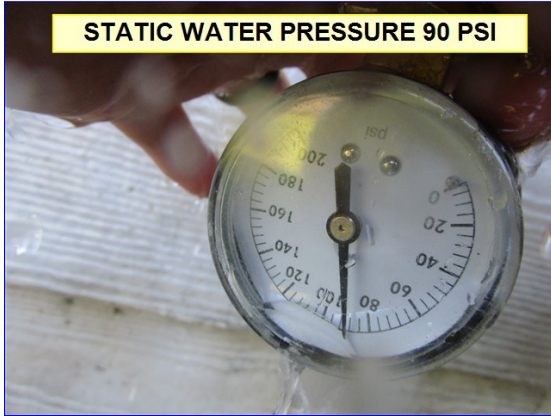
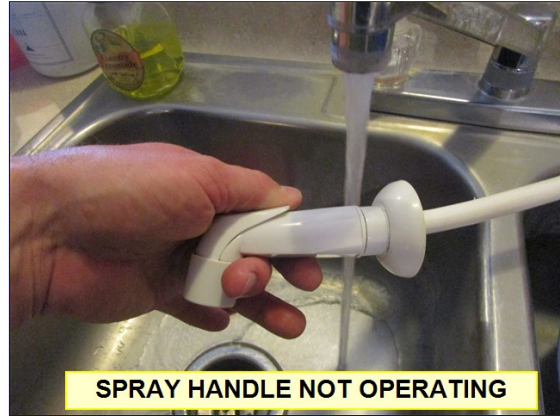
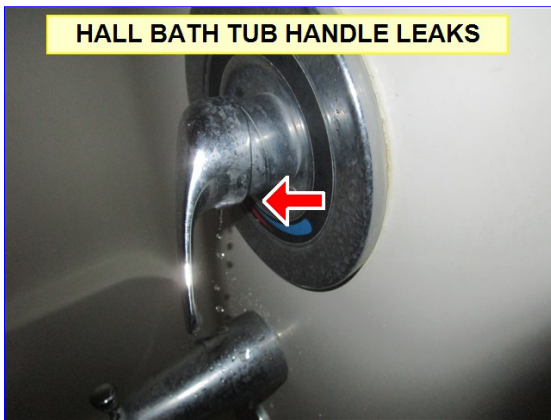
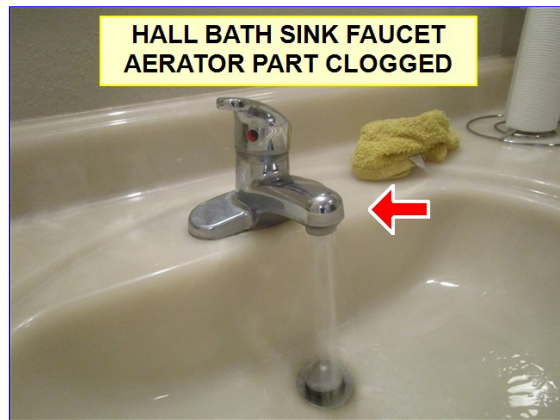
The hall bathroom tub handle leaks when operating.

The static water pressure should range between 40-80 PSI. The static water pressure was over 80 PSI at the time of this inspection. **Recommend installing a pressure regulator at the meter.** *There is a higher risk for leaks at the plumbing fixtures and/or water supply lines when the water pressure exceeds 80 PSI.*

The kitchen faucet was loose from the sink.

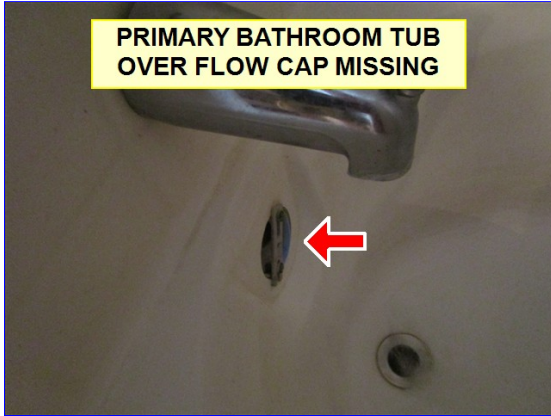
B. Item 1(Picture)

The primary bathroom tub overflow cap was missing.

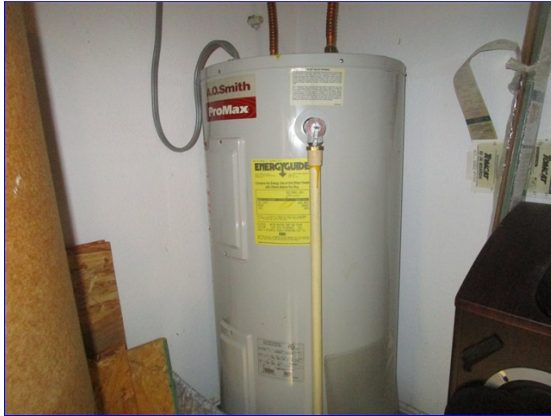
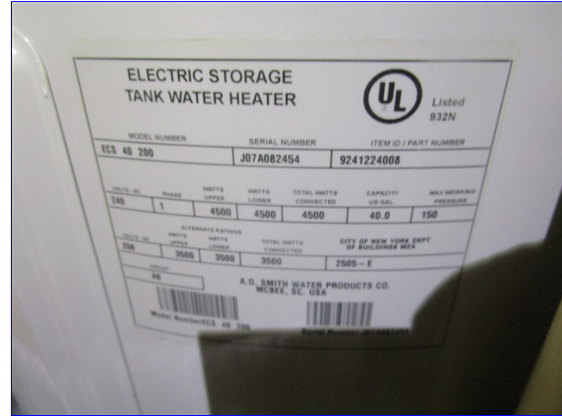
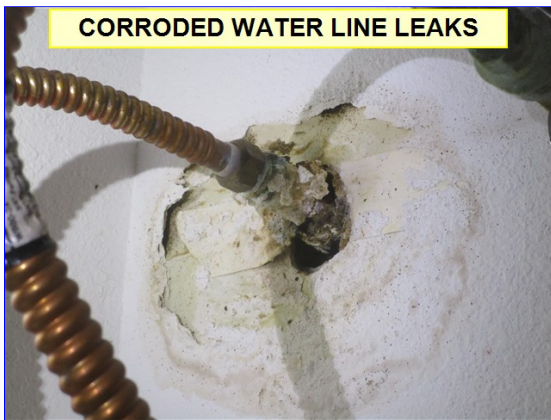
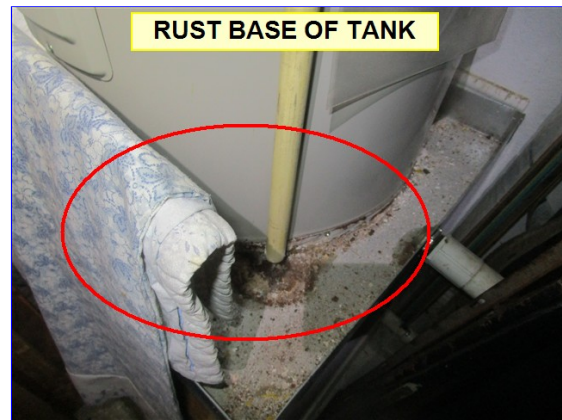
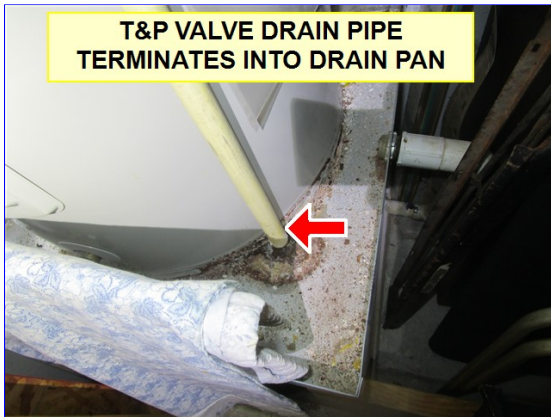
There was rust along the base of the tank. **Recommend immediate replacement.**

The water supply line was corroded and leaks. **Recommend immediate replacement.**

The water pressure was over 80 PSI at the time of this inspection. Adding a pressure regulator at the meter has been recommended. TREC requires an expansion tank be added to the water heater when a pressure regulator is present.

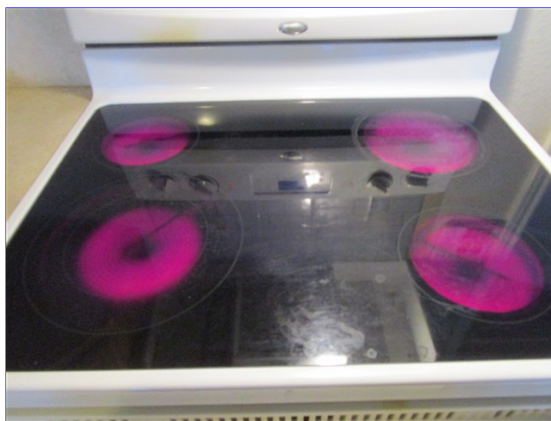
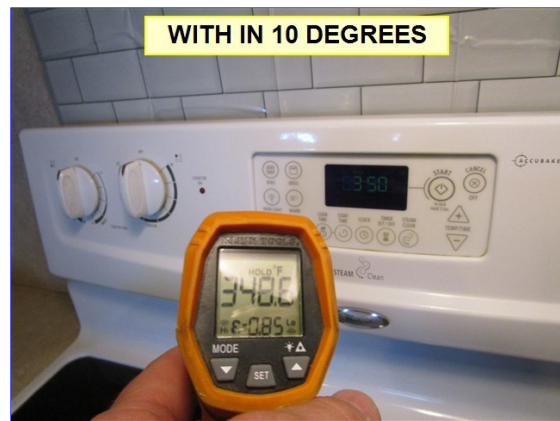
Current building standards require the dishwasher drain to be above the sink drain. This prevents the sink from draining back into the dishwasher drain line. Simple repair: just secure the drain line above the sink.

This is a stand alone range. There was not an anti tip brace in stalled. *This is a safety hazard.*

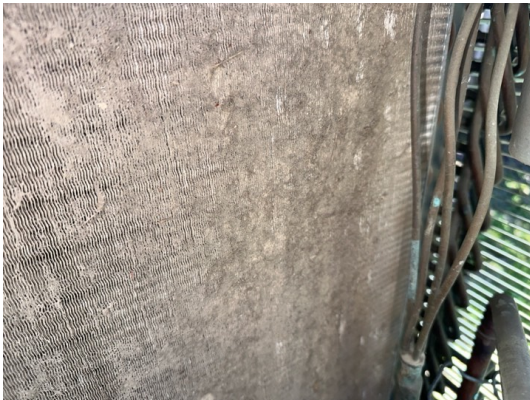
CONDENSER COIL

7: Condenser coil is dirty and should be cleaned to allow proper airflow through condenser coils.

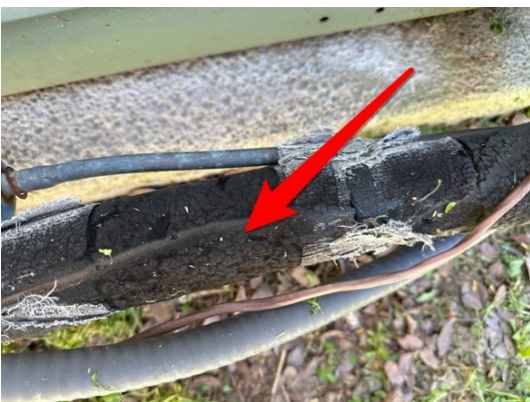
INSULATION

11: Insulation is in poor condition or missing on the suction line at the condenser, this should be insulated to prevent condensation.

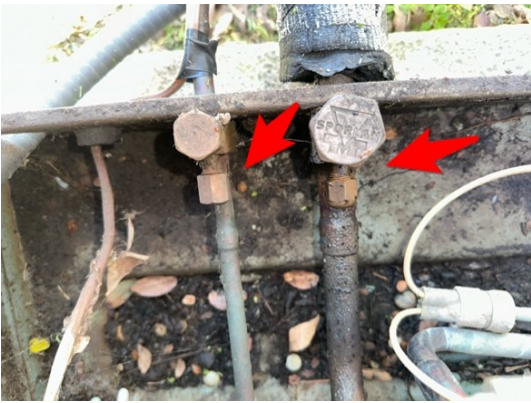
SERVICE PORTS

14: Locking caps are required per code to be installed on the service ports of the condenser.

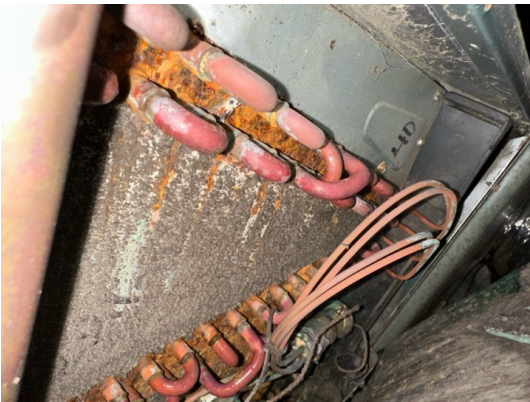
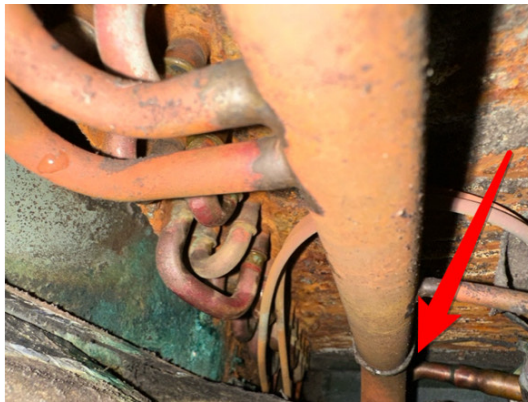
EVAPORATOR COIL

18: Leak checked system with electronic leak detector. Leak detector was picking up traces of refrigerant oil in the evaporator coil. The evaporator coil has a non-repairable leak.

26: Recommended repairs include: Due to the Freon leak on the R22 system we would recommend a full system replacement with a Bryant 3 ton horizontal heat pump system to include locking caps, float switches, secondary heating elements, emergency drain pan and duct adaptations.
